What Happened to BLITS? An Analysis of the 2013 Jan 22 Event

T.S. Kelso
Center for Space Standards & Innovation
N.N. Parkhomenko, V.D. Shargorodsky, V.P. Vasiliev, V.S. Yurasov
Open Joint-Stock Company Research-and-Production Corporation
"Precision Systems and Instruments"
A.I. Nazarenko
Scientific and Technological Center "KOSMONIT"
S. Tanygin
Analytical Graphics, Inc.
R.M. Hiles
Joint Space Operations Center

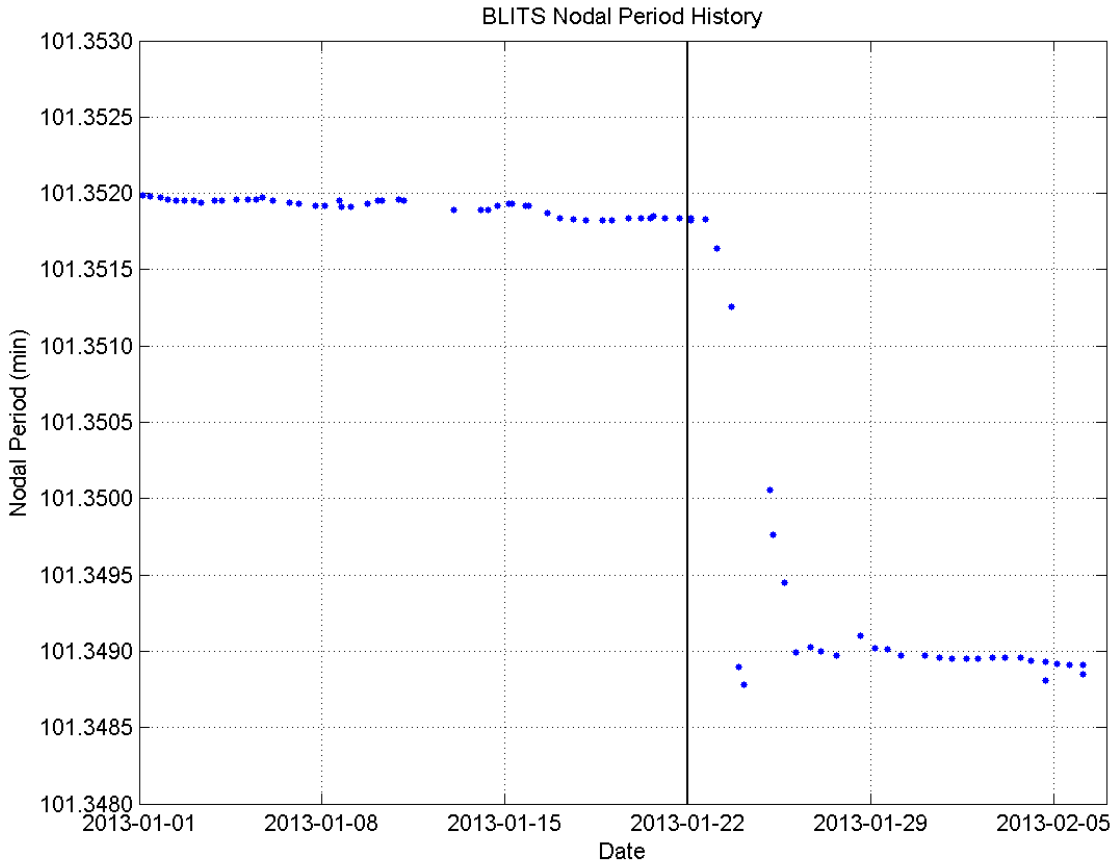
Fig. 2. BLITS Nodal Period History

Within a day, NORAD two-line element sets (TLEs) produced by the Joint Space Operations Center (JSpOC) began showing a clear change in the orbital period for BLITS (see Fig. 2). By Jan 26, it was clear that the mean semi-major axis had decreased by 127–142 m. Since BLITS had no propulsion or attitude control systems, some event had occurred to cause this change.

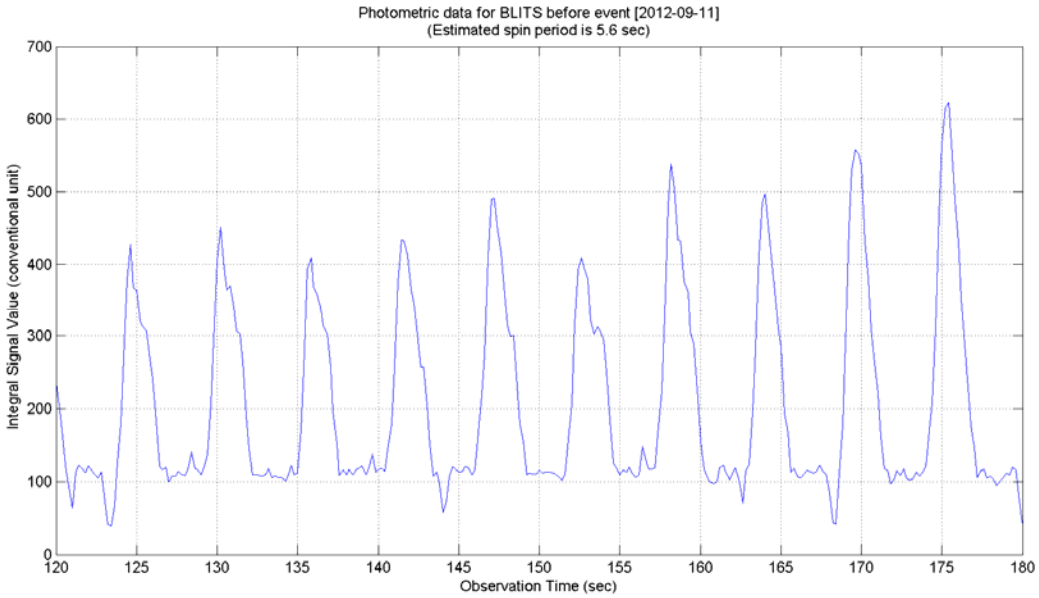
Fig. 3. BLITS Pre-Event Photometric Data from 2012 Sep 11

Researchers at the Korea Astronomy and Space Science Institute and the Space Research Institute of the Austrian Academy of Sciences have collected extensive observations to determine the BLITS spin rate and spin axis orientation over the period from 2009 Sep 26 to 2012 Jun 18 [5]. They determined a mean spin period of 5.613 s, RMS = 11 ms. This result is supported by observations collected by OJSC RPC "PSI" on 2012 Sep 11 (Fig. 3).

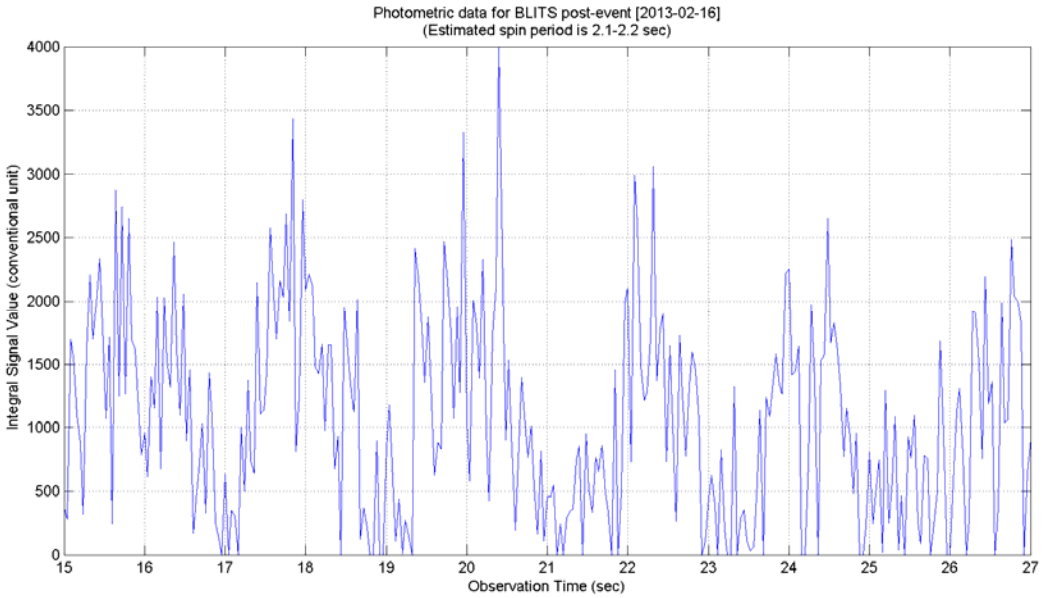
Fig. 4. BLITS Post-Event Photometric Data from 2013 Feb 16

However, in observations collected after the event on 2013 Feb 16, it is clear that the spin period had changed significantly (Fig. 4), with a new estimated spin period of 2.1–2.2 sec. Contrary to expectations based on the principle of conservation of angular momentum, it would appear that the angular momentum actually increased significantly as a result of the event.

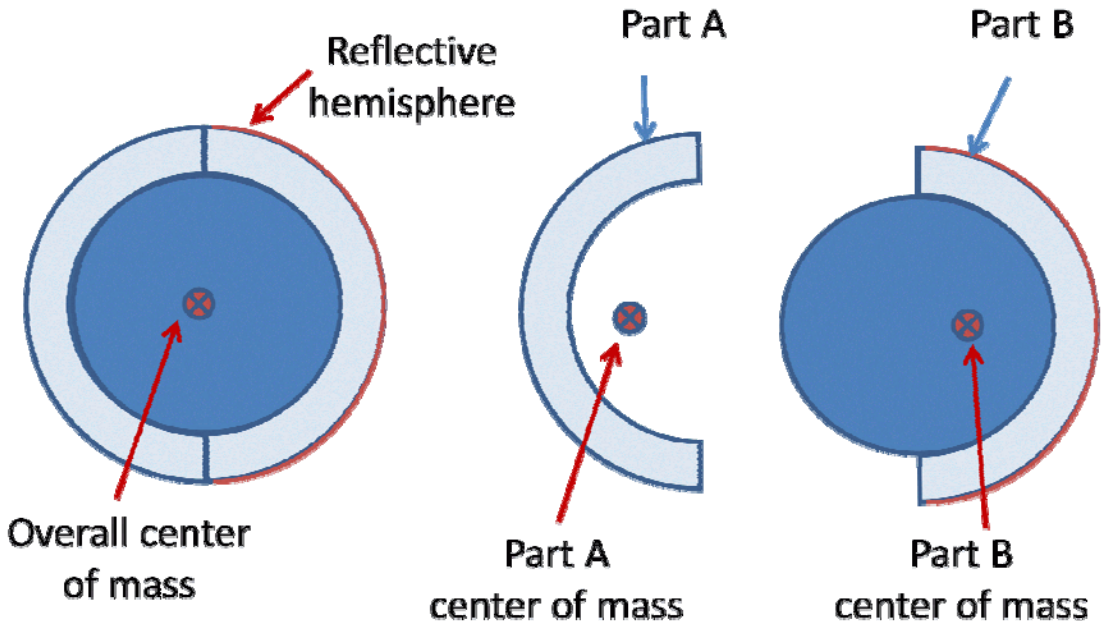
Fig. 5. BLITS Mechanical Failure Hypothesis

Given the simple design of BLITS, it was possible to perform detailed analysis examining the moments of inertia before and after the event, along with the measured spin rates and spin orientation, to determine the expected spin rate after a simple mechanical failure, as shown in Fig. 5.

Factoring in the measured pre-event spin rates and spin orientation, along with the moments of inertia of the pieces before and after the breakup, AGI showed that the spin rate would increase slightly from 61.4 deg/s to 71.7 deg/s (spin period change from 5.6 s to 5.0 s). Clearly, this type of breakup could not explain the observed change in spin rate.

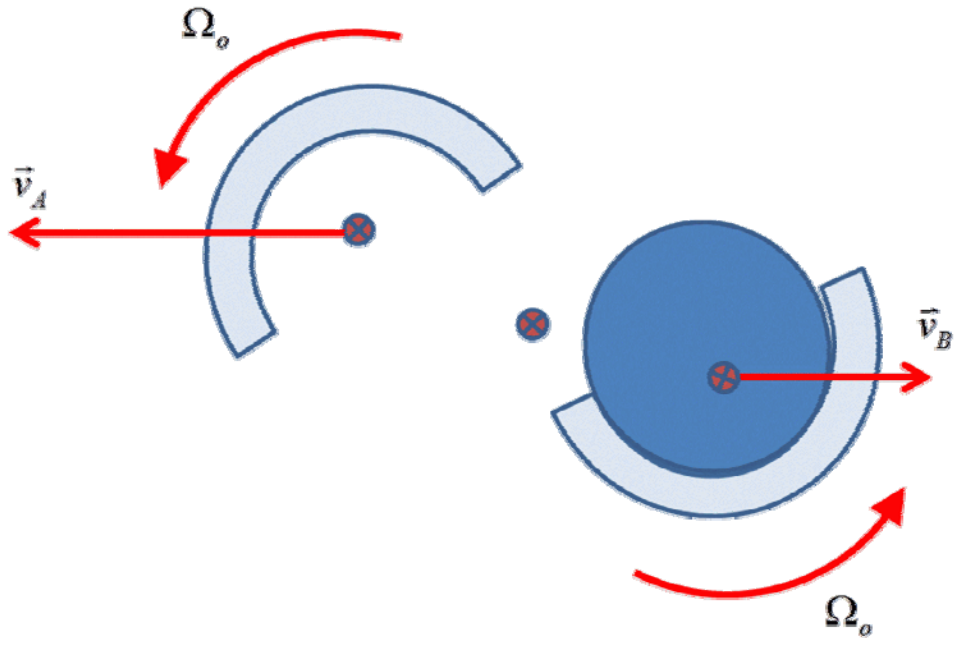
Fig. 6. BLITS Post-Breakup Spin and Velocities

BLITS satellite prior to the breakup. That work also showed it was possible to impart a change in velocity for each piece relative to the pre-event BLITS orbit, as shown in Fig. 6.

AGI also showed that the breakup would impart a change in velocity of 2.84 cm/s for the smaller piece and 1.71 cm/s for the larger piece. Calculating the state for BLITS (Element Set 623) at the JSpOC event time of 03:06:50 UTC and knowing the specific energy to be:

a decrease in the semi-major axis of 127–142 m would require a change in velocity of 6.6–7.4 cm/s (independent of the mass of the object)—apparently too large to be caused by the breakup hypothesis. Note that a breakup producing a smaller debris object would mean the parent object was more massive than considered in this analysis and would have an even lower change in velocity, effectively ruling out all possible spontaneous breakup events.

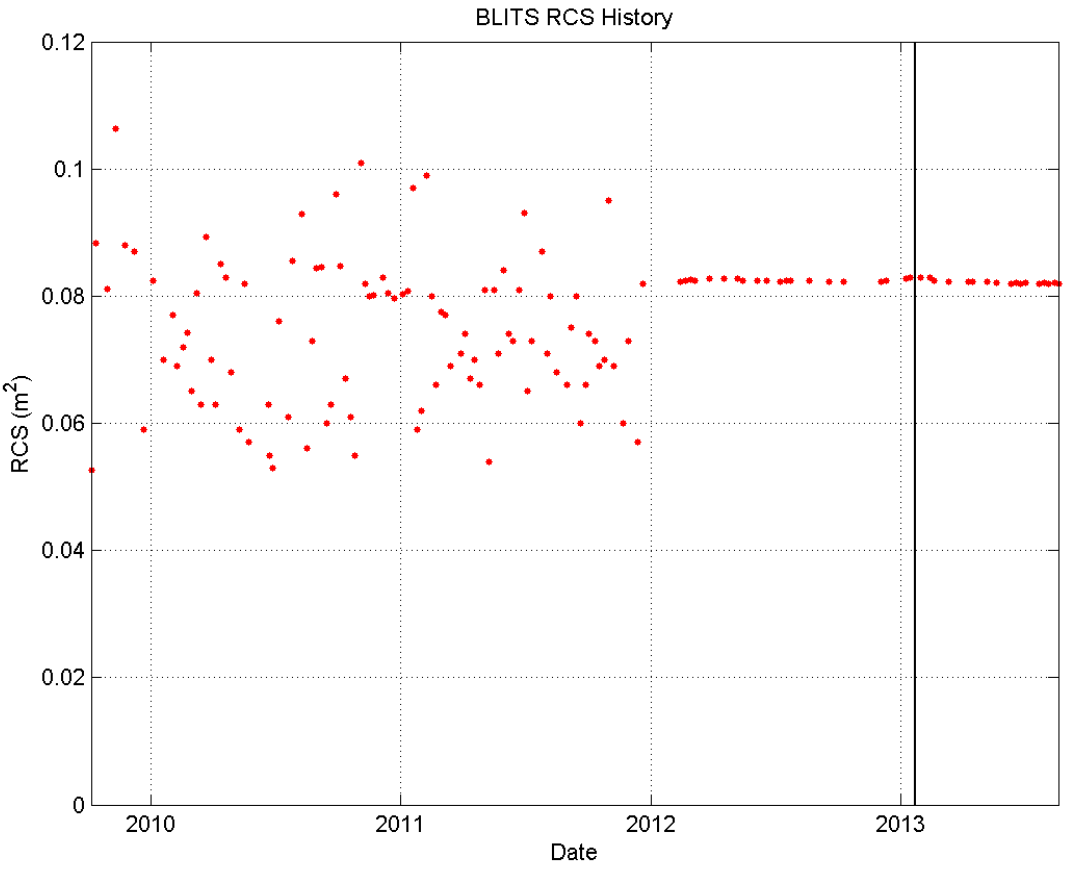
Fig. 7. BLITS RCS History

The final piece of evidence weighing against a simple mechanical failure can be found in the radar cross-section (RCS) data provided by the JSpOC. As can be seen in Fig. 7, the measured RCS values for BLITS have been very stable, with a value of 0.082 m^2, since the beginning of 2012. There is very little, if any, change in the RCS value after the event. When combined with the RCS value of 0.0018 for the BLITS debris—a factor of almost 7 smaller in size or about 2.5 cm—it would be far too small to represent even the smallest piece of a simple mechanical breakup (the inner sphere at 10.7 cm).

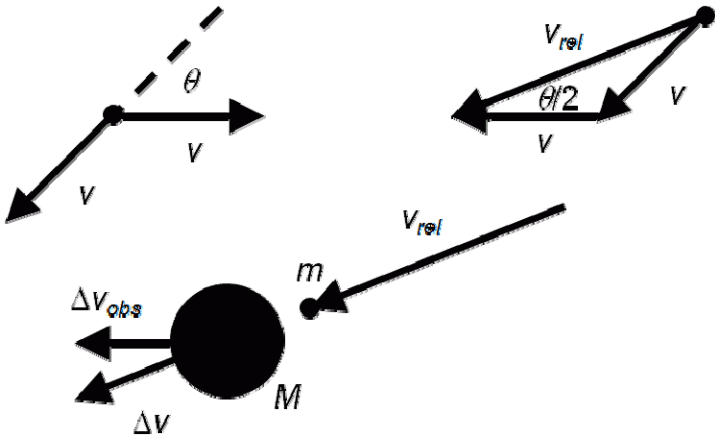
Fig. 8. Encounter Geometry

In fact, if we look at encounter angles (the angle θ in Fig. 8) less than 180º and assume the untracked object has the same orbital speed as BLITS, it is possible to repeat these calculations to determine the corresponding object size required to produce the observed change in semi-major axis as a function of the encounter angle. As the encounter angle increases, the relative velocity decreases, and a larger overall change in velocity is required to produce the observed in-track change in velocity. The results are shown in Fig. 9.

Even at an encounter angle of 175º (coming from behind), where the relative velocity is 650 m/s, a spherical object with the same density as BLITS and a diameter of 1.86 cm can produce a decrease in the semi-major axis of 142 m. Fig. 9 clearly shows that it would be possible to produce the observed results for virtually any encounter geometry and still be too small to be tracked by the SSN.
